Monthly Progress Report No. 7
514 Union Street
Brooklyn, New York
Brownfield Cleanup Program (BCP) Site No.: C224318
Reporting Period: February 2023

In accordance with the reporting requirements of the 21 October 2022 Brownfield Cleanup Agreement (BCA) for the 514 Union Street site, Langan Engineering, Environmental, Surveying, Landscape Architecture and Geology, D.P.C. (Langan) prepared this monthly progress report, on behalf of Gowanus President Owner LLC (the Volunteer), to summarize the work performed at 514 Union Street in Brooklyn, New York during February 2023. A BCA Amendment to add the Volunteer, Gowanus President Owner LLC, was executed on 1 February 2023.

The 3 February 2023 Interim Remedial Measures Work Plan (IRMWP) No. 2 for in-situ groundwater remediation was approved by NYSDEC and New York State Department of Health (NYSDOH) on 3 February 2023.

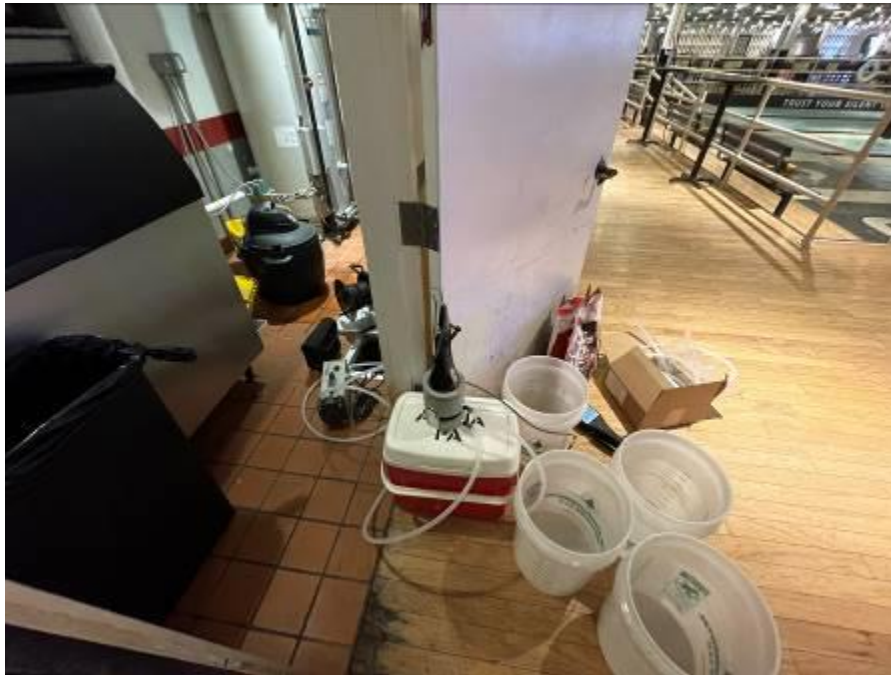
Photo 1: Groundwater sampling setup at monitoring well MW08D (facing west).

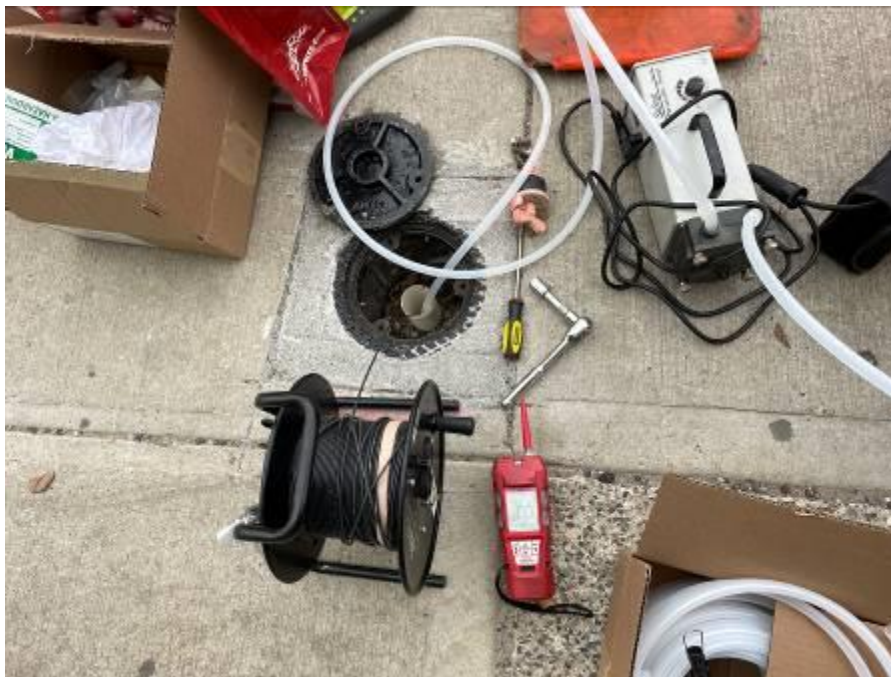
Photo 2: Groundwater sampling setup at monitoring well HRP-MW-1.

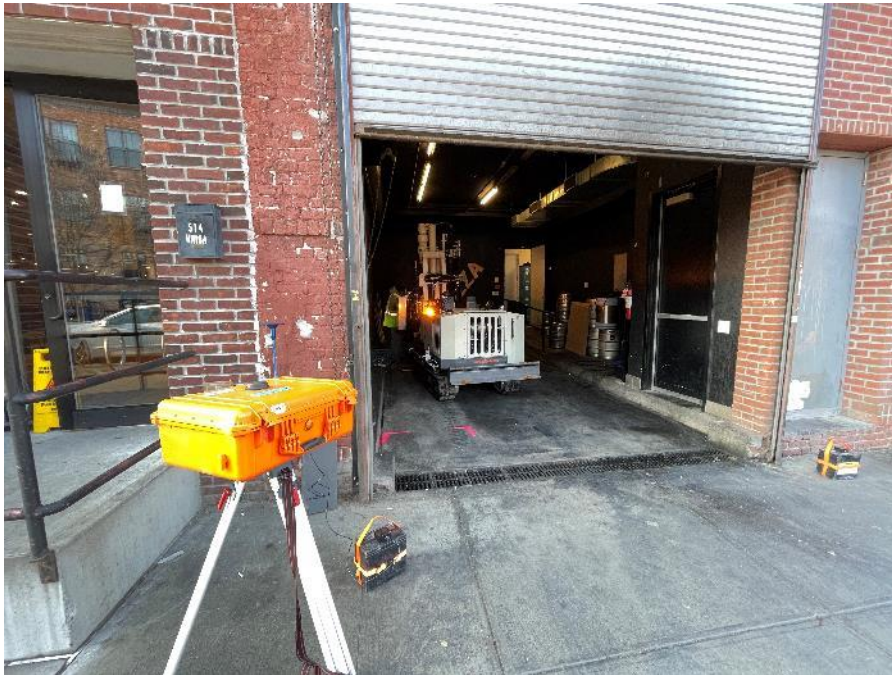
Photo 1: Coastal Environmental installing monitoring well MW15D (facing south).

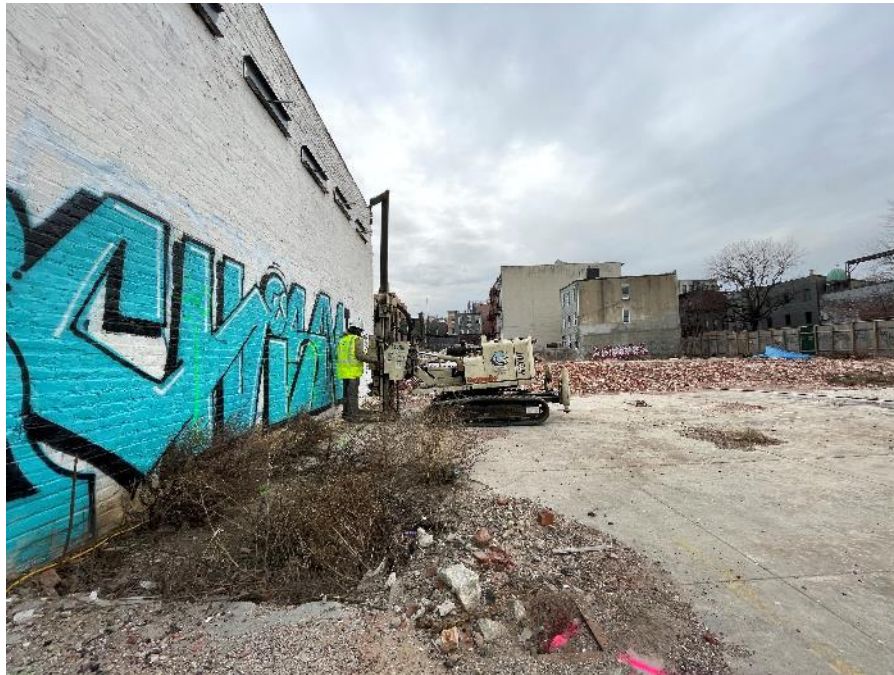
Photo 1: Coastal Environmental advancing soil boring SC-1 (facing east).

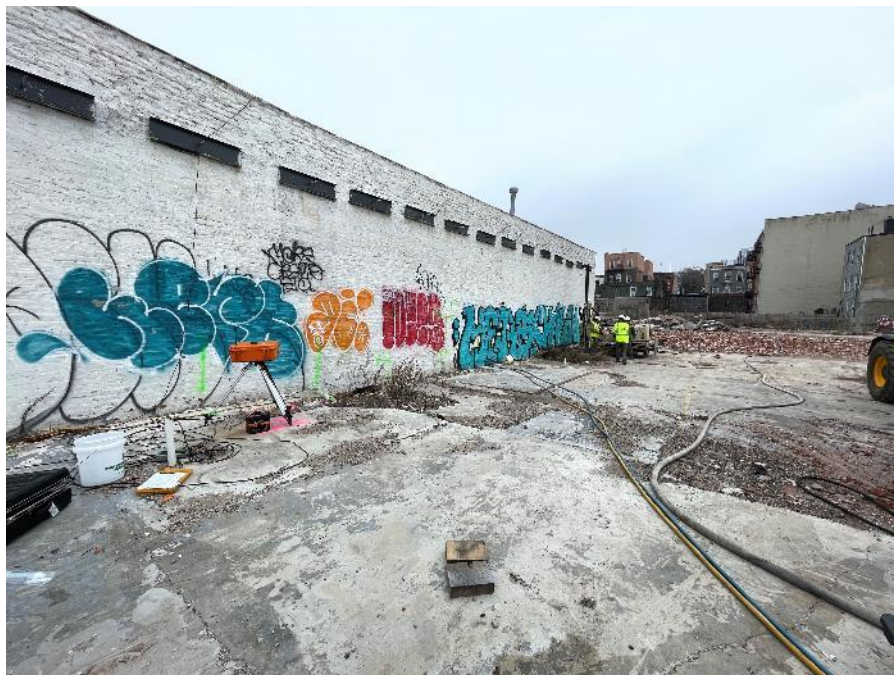
Photo 2: Regenesis applying remedial products at injection point IP-42 (facing east).

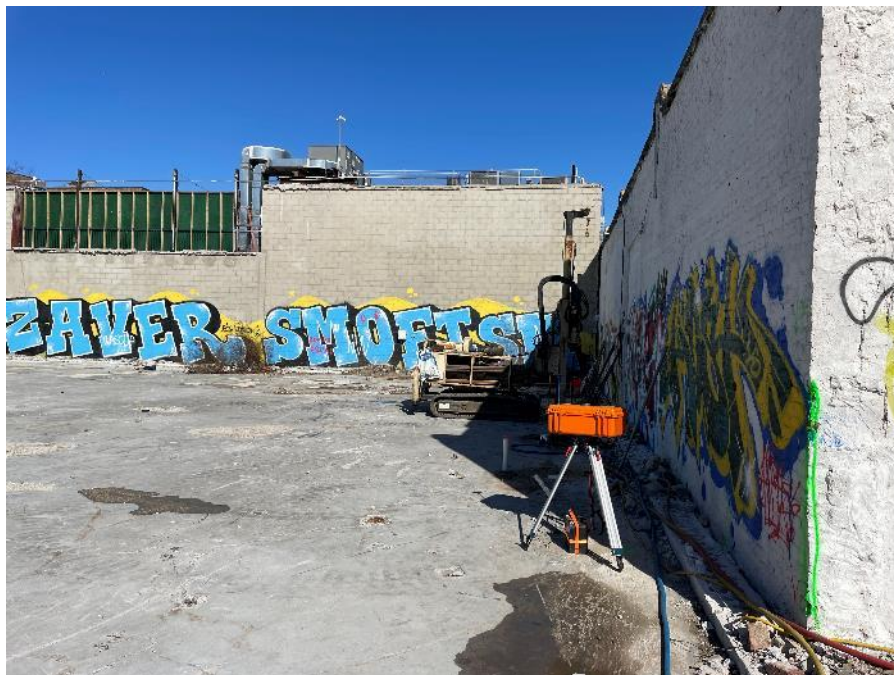
Photo 2: Regenesis applying remedial products at injection point IP09 (facing north).

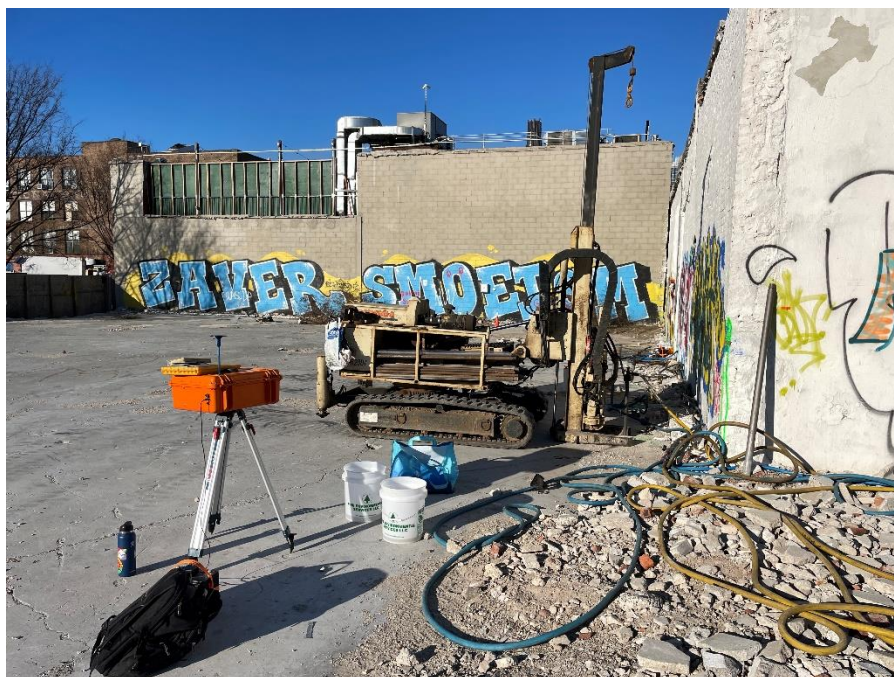
Photo 2: Regenesis applying remedial products at injection point IP14 (facing north).

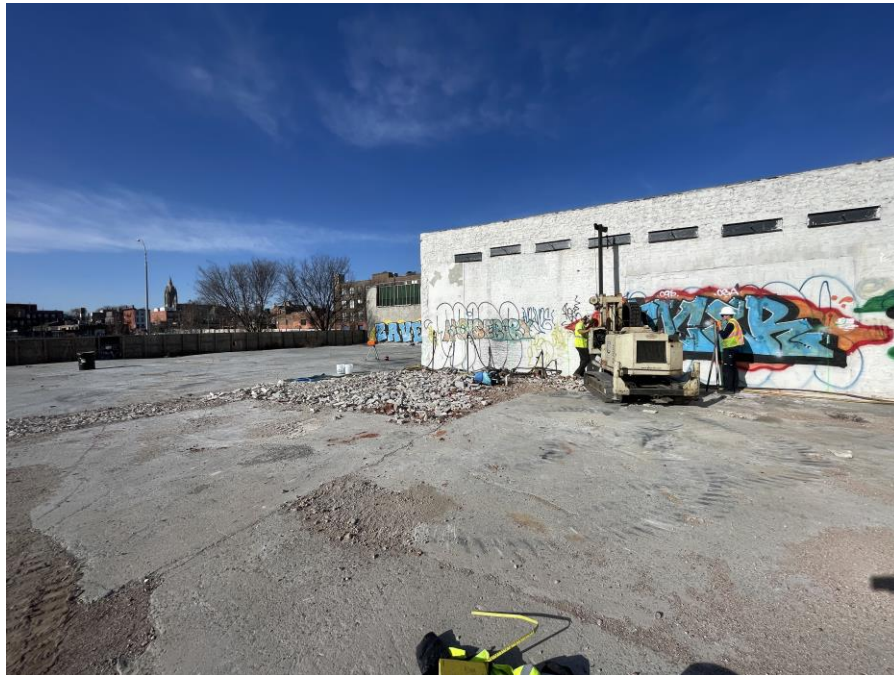
Photo 1: Regensis applying remedial products at injection point IP18 (facing north).

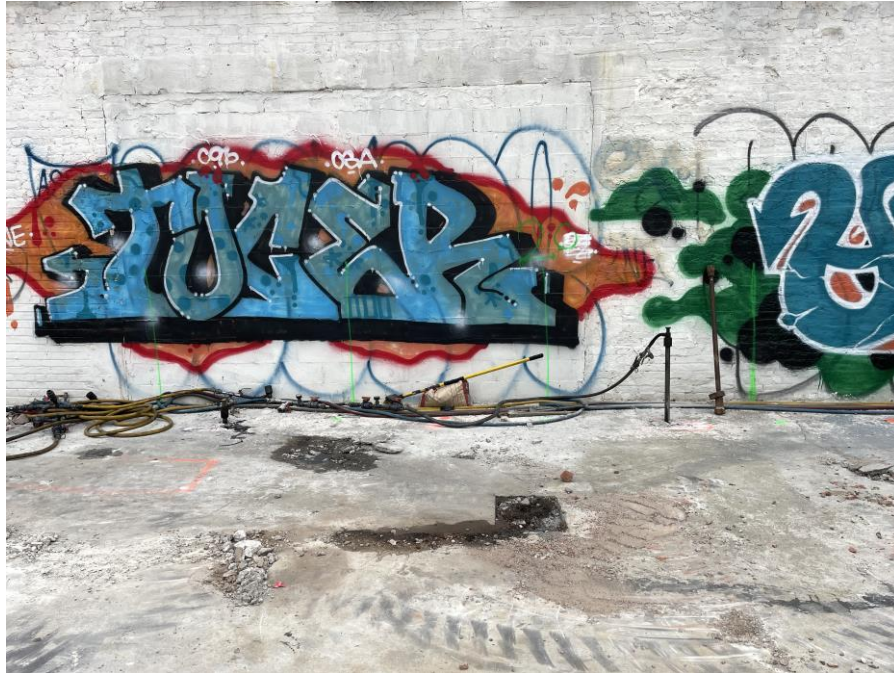
Photo 1: Regenesis applying remedial products at injection points IP19 and IP21 (facing north).

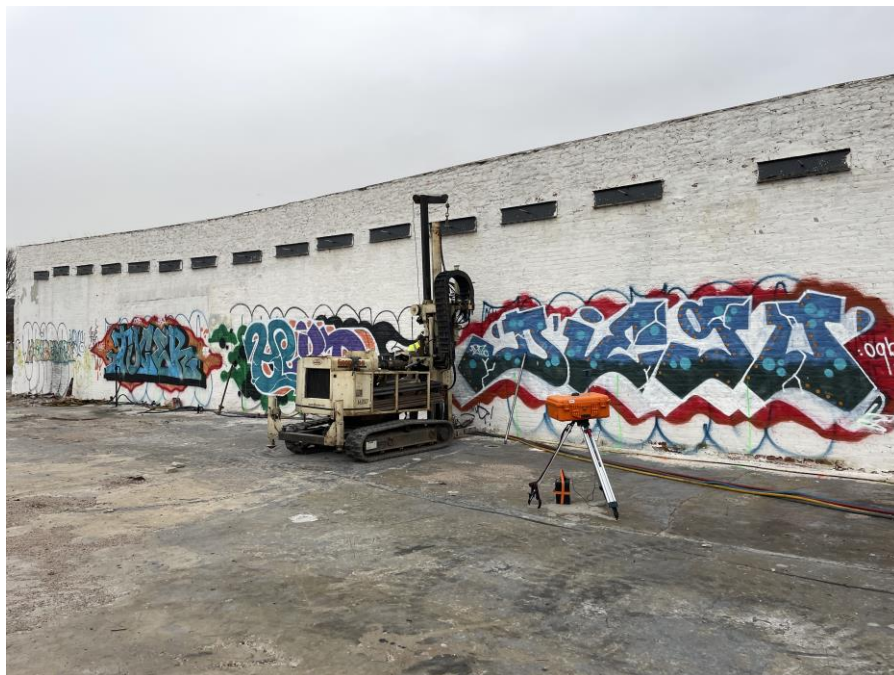
Photo 2: Regenesis applying remedial products at injection point IP25 (facing north).

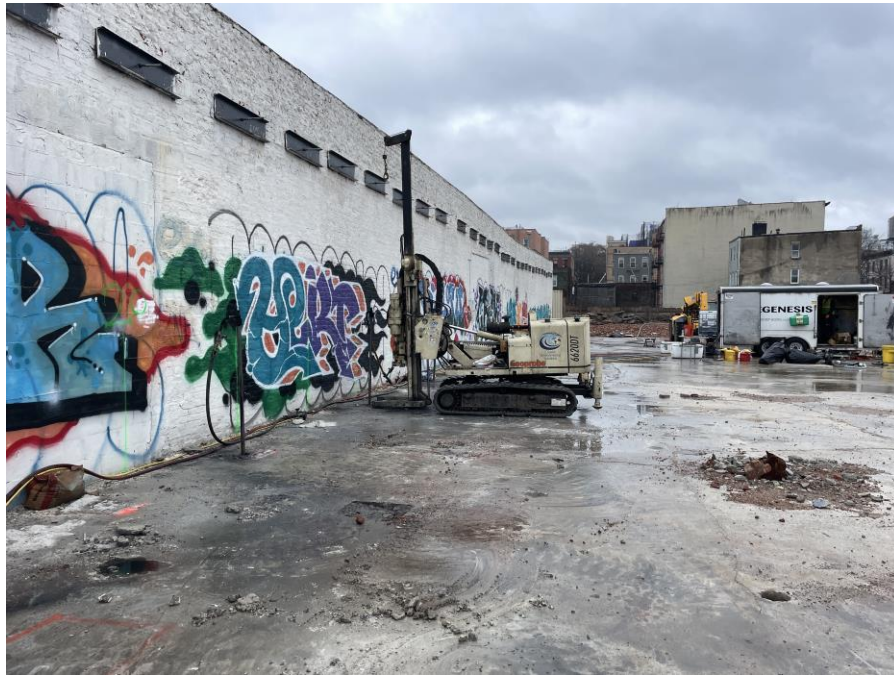
Photo 1: Regenesis applying remedial products at injection points IP23 and IP25 (facing east).

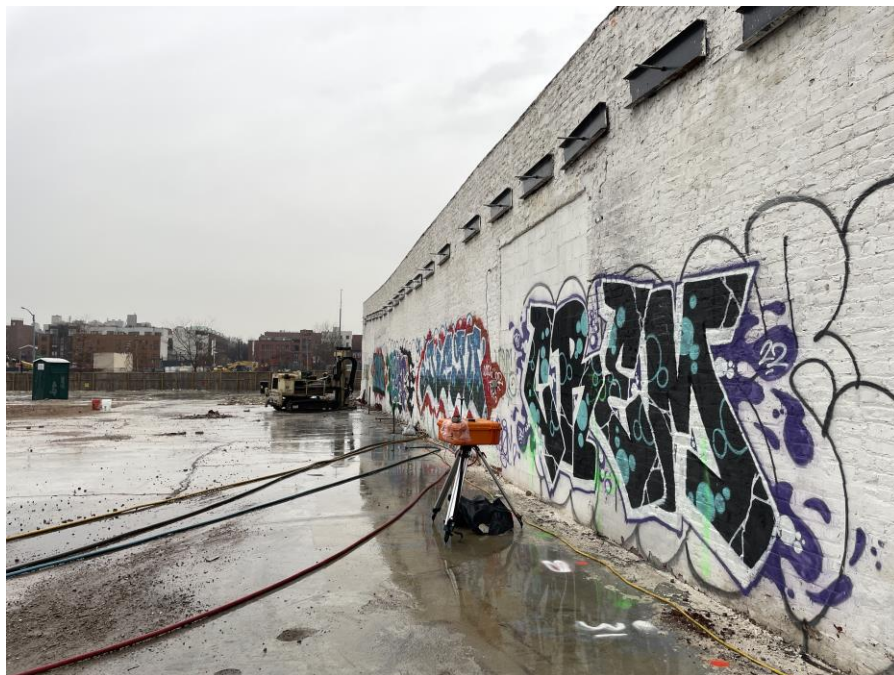
Photo 2: Regenesis applying remedial products at injection point IP19 (facing north).

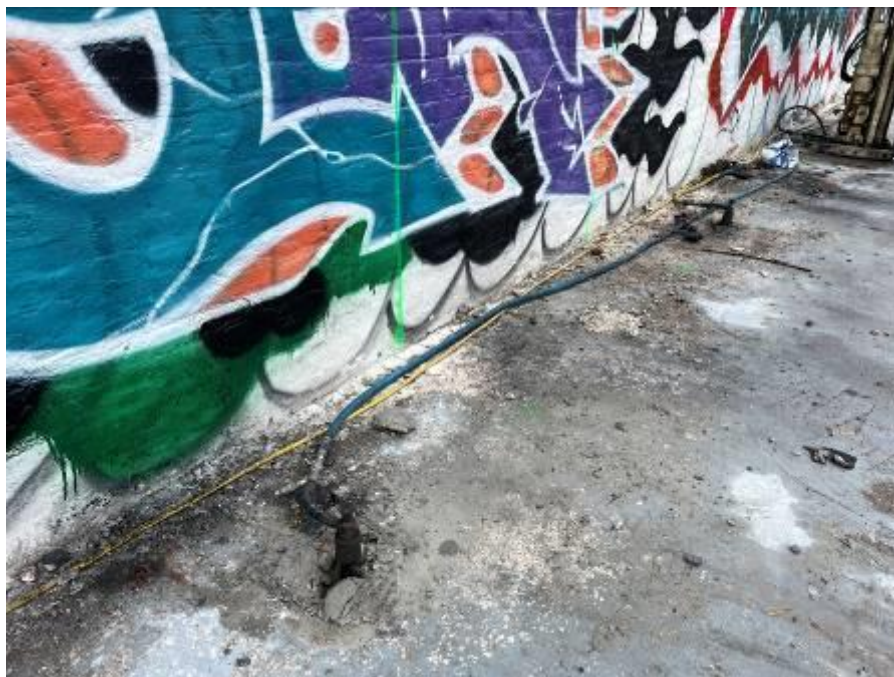
Photo 2: Regenesis applying remedial products at injection points IP22 and IP24 (facing northeast).

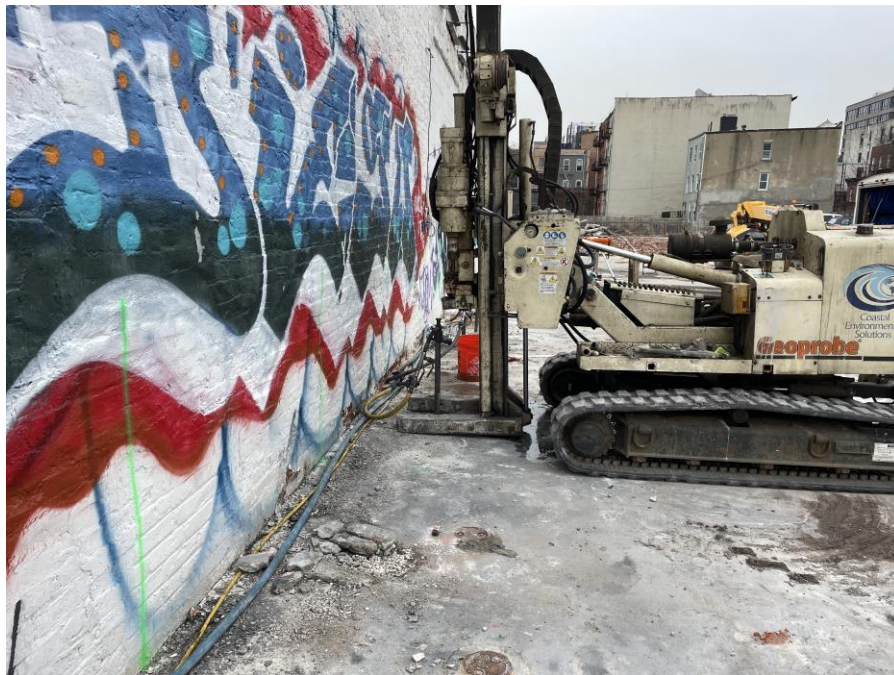
Photo 1: Regenesis applying remedial products at injection point IP27 (facing east).

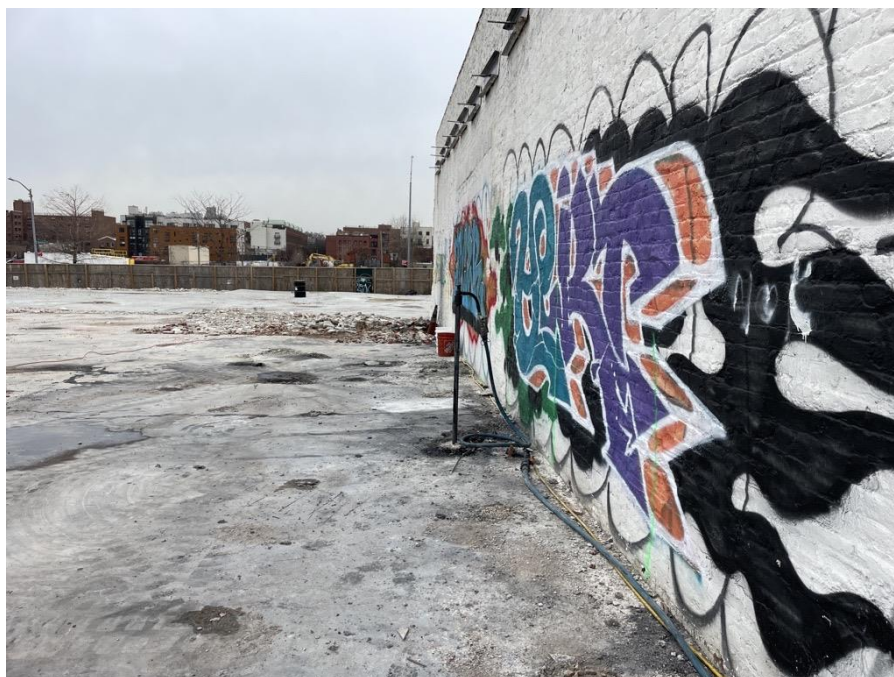
Photo 2: Regenesis applying remedial products at injection points IP22(facing west).

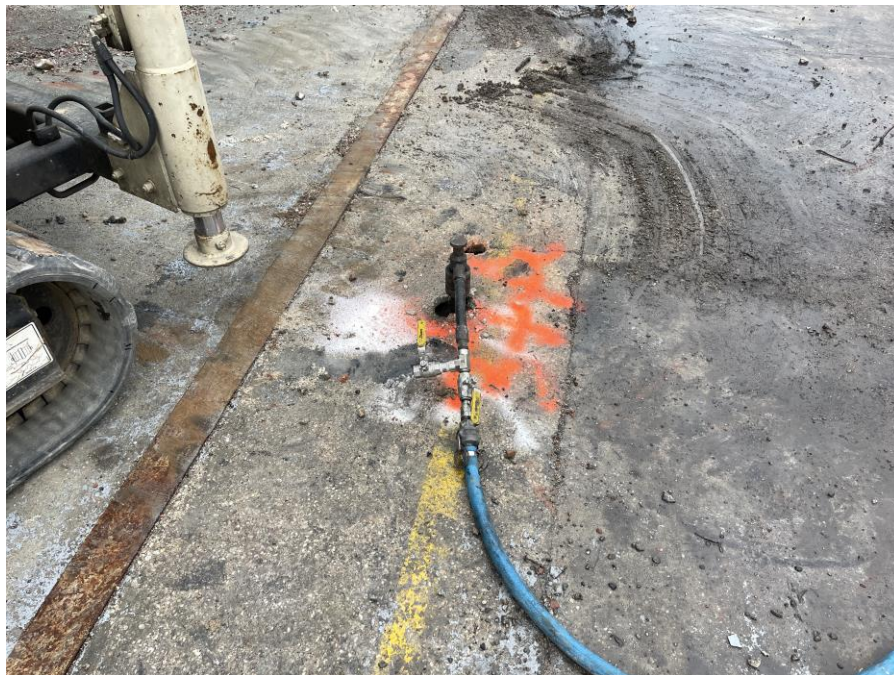
Photo 1: Regenesis applying remedial products at injection point IP37A (facing northeast).

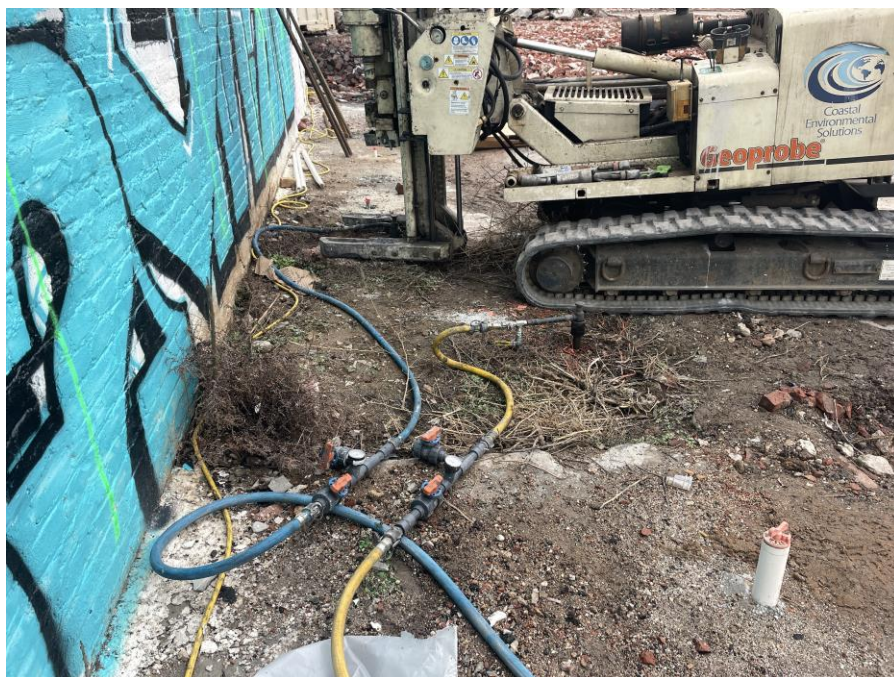
Photo 2: Regenesis applying remedial products at injection points IP39A and IP40 (facing east).

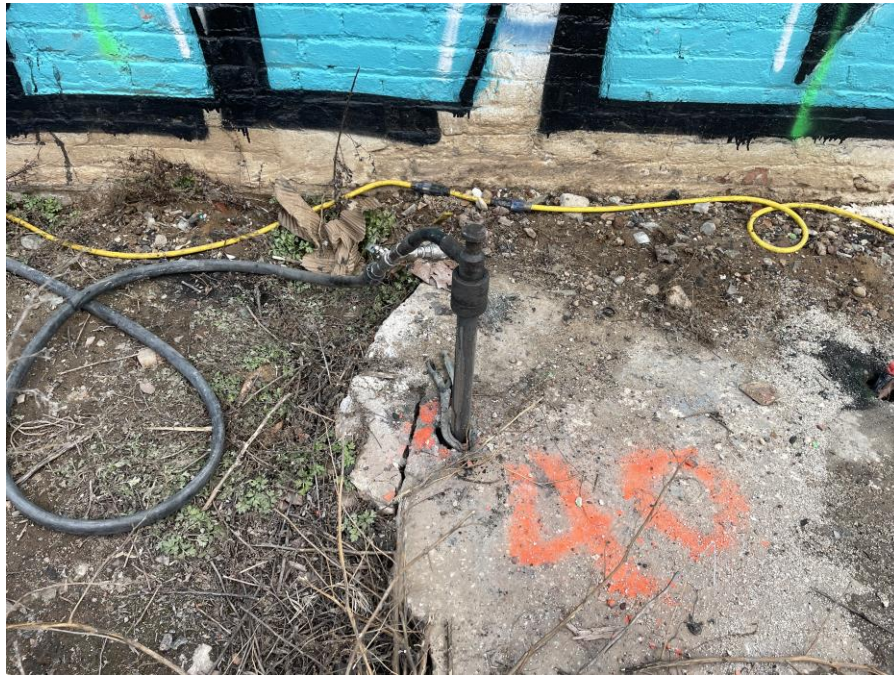
Photo 1: Regensis applying remedial products at injection point IP40 (facing north).

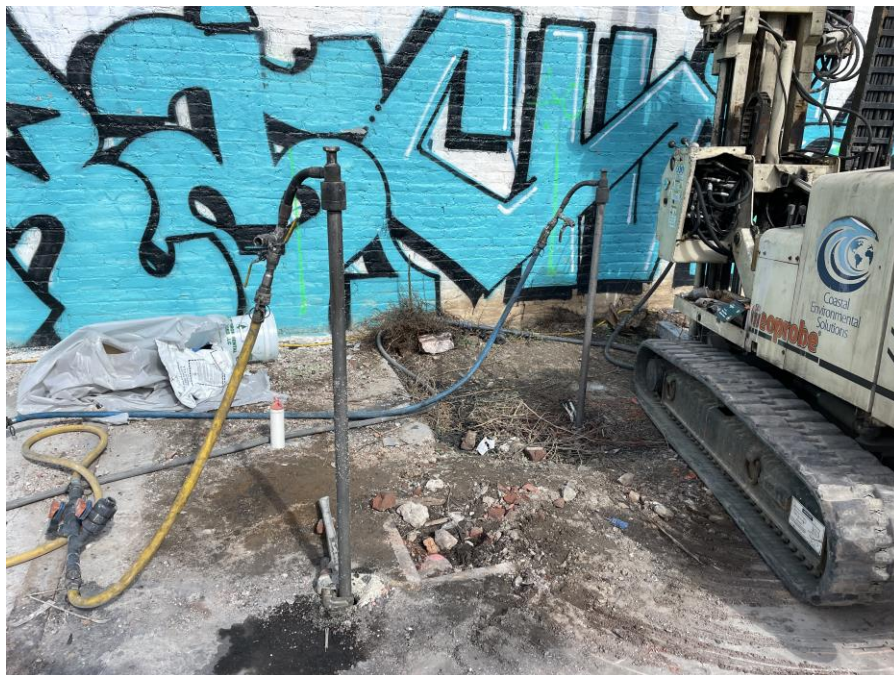
Photo 2: Regensis applying remedial products at injection points IP39B and IP39A (facing north).

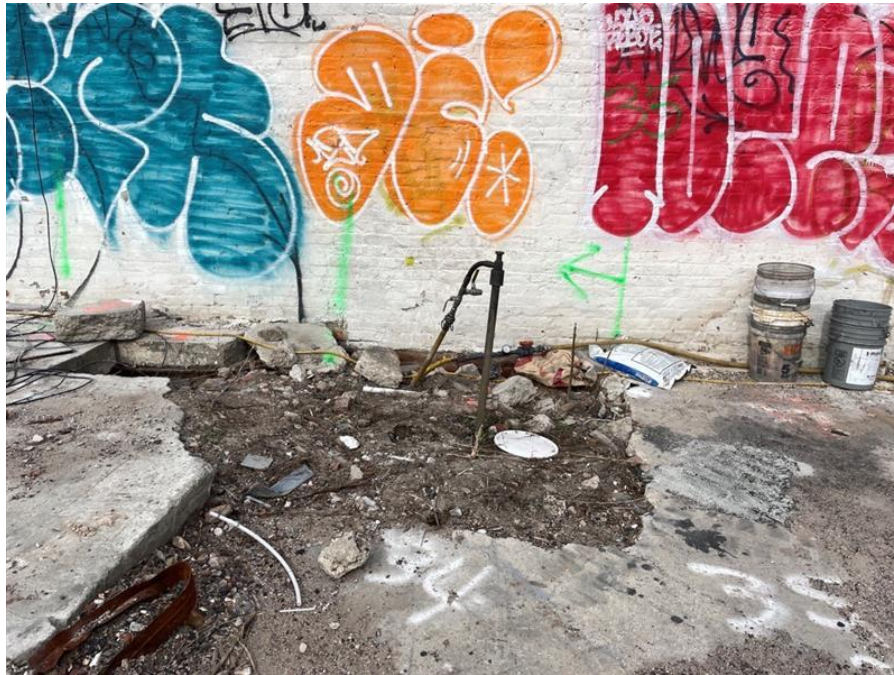
Photo 1: Regenesis applying remedial products at injection point IP35 (facing north).

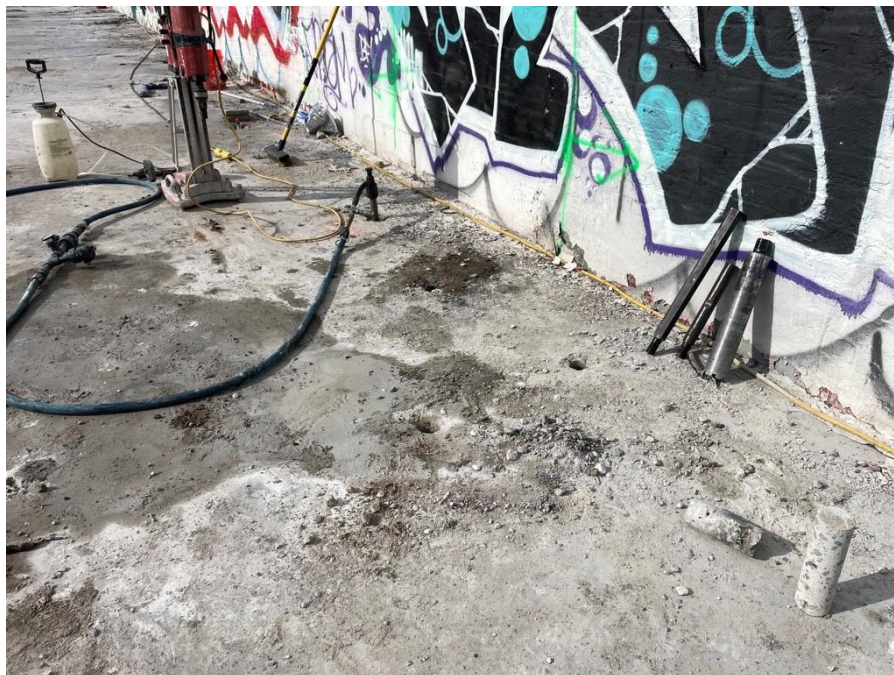
Photo 2: Regenesis applying remedial products at injection point IP30 (facing northwest).

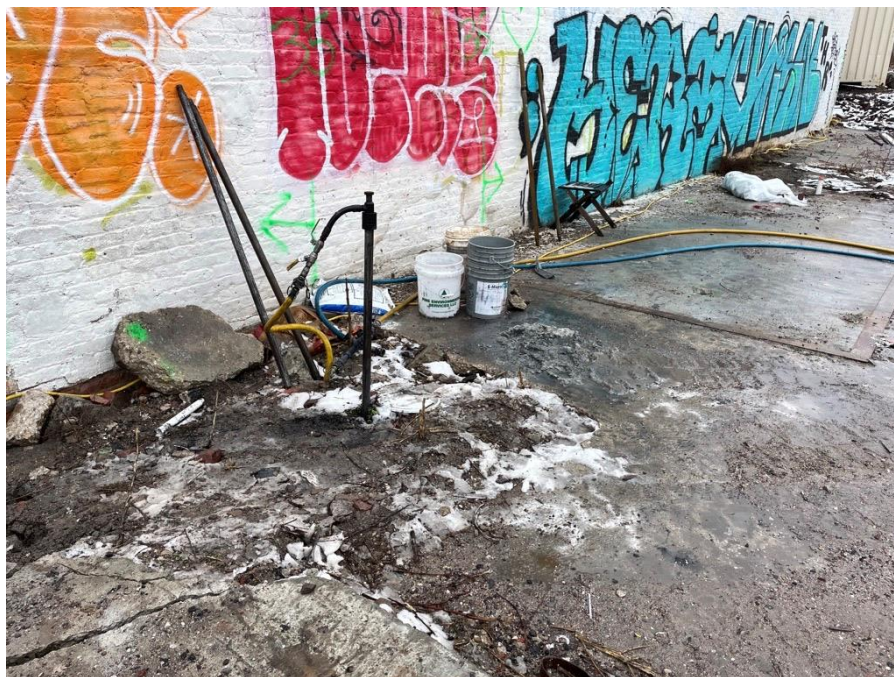
Photo 1: Regenesis applying remedial products at injection point IP35 (facing northeast).

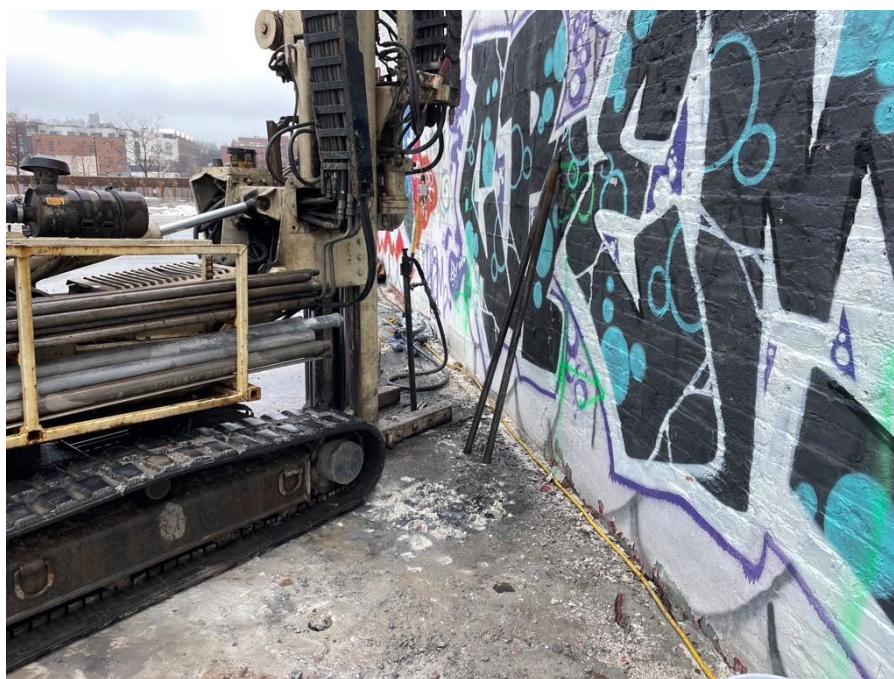
Photo 2: Regenesis applying remedial products at injection point IP30 (facing northwest).
